Devon and Cornwall Land Management Team Catchment Assessment of Ide, Exeter, Devon. 02.02.2024

Compiled by: Daniel Halford, Land Management Project Officer, Environment Agency.

This report presents the findings of a land management assessment of land South of Ide, Exeter, Devon.

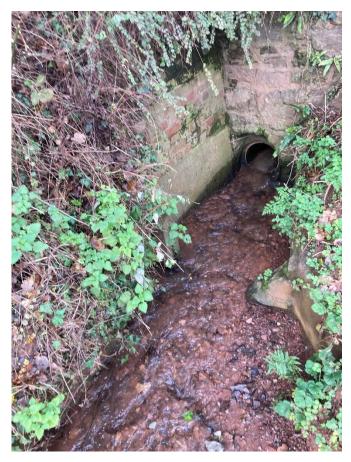
Figure 1- Culvert south of Ide

A culvert (Figure 1) which collects the water from a tributary to the south of Ide and passes below houses and the road where it connects to the Fordland Brook. This culvert became blocked with debris and rubble during the storm event, overtopping and flooding the adjacant property.

- e) Catchment sensitive farming advice given to land managers. This presents opportunities for funding and implementing measures that may have benefits for flooding and water quality.
- f) Assessment of the culvert near the community affected. Is it adequate can it be improved, what's the cost benefit assessment of this work?
- g) Creation of an overflow/ spillways near houses and community affected. This will provide a safe exit route for excess water.
- h) Assessment and management of downstream infrastructure and drainage network to ensure the is sufficient opportunity for surface water to get away.

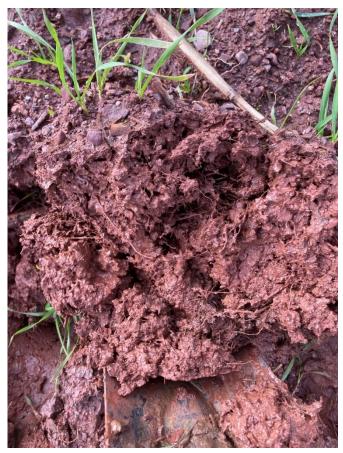
Figure 3- Soil sample field 1

Field 1 (Figure 4) Was a recently sown crop of winter wheat following maize. The established crop of winter wheat had good soil structure (Figure 3) and crop cover was emerging. There was no evidence of significant soil erosion and runoff, although the lower part of the field in the fluvial zone had been affected by fluvial flooding, where loosened maize stubble is at risk of being transported in flood waters. It was concluded that this field had good soil structure that would allow natural infiltration.

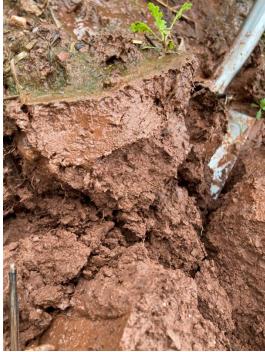
Figure 7- Soil profile

The previous crop was an arable cereal where the stubble had been direct drilled to establish a grass crop, however this crop had failed to establish. There were two areas noted that where accepting significant highway water, this water was not accepted by the soil and travelled following the natural overland flow path through the catchment. The soil had a sealed soil surface where algal growth was developing, indicating poor water infiltration into the soil profile. This sealed soil surface also showed evidence of overland flow. From approximately 0-20 cm there was a poor dense, blocky soil structure, where evidence of smearing had been caused from the direct seed drill (Figure 7). There was limited evidence of biological activity. From 20-40cm (figure 9) there was also a dense blocky and angular structure that would not support good water infiltration. The soil was noticeably dryer at depth than the soil on the surface, showing the water on the soil surface was perched.

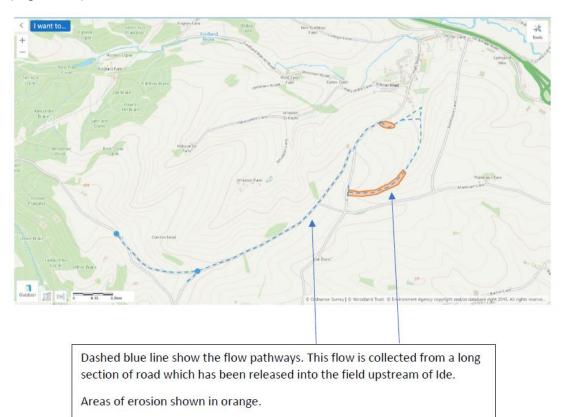
Overland flow is generated from field 4 (Figure 9) where it is mainly conveyed down the local highway, predominantly into field 2 although where not intercepted by the road drainage this excess water will make its way to the community of Ide via the road network (Figure 10). Where the flow pathway is conveyed through field 2 significant erosion occurs enabling significant levels of debris to be transported in high flows. Where overland flows travel through field 3 (Figure 11) significant surface water runoff occurs, when significant velocity develops soil erosion increases. Vegetation, floodplain connection and surface roughness will help to mitigate the impacts of high flows and sediment laden surface water. Between field 3 and field 1 there is a section of rough grassland where sediment deposition has occurred (Figure 12).

The overland flow generated from field 4 is conveyed through and alongside the highway network this increases the natural catchment area and water volume passing through field 2 and along the road into Ide. Manitenance of road drainage is required alongside seeking oportunities to desperce the water volume and encourage a more natural flow pathway for the landscape.
