Devon and Cornwall Land Management Team Catchment Assessment of Ide, Exeter, Devon. 02.02.2024

Compiled by: Daniel Halford, Land Management Project Officer, Environment Agency.

This report presents the findings of a land management assessment of land South of Ide, Exeter, Devon.

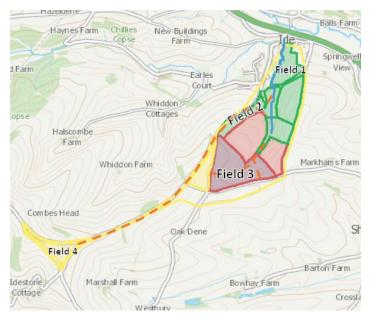
Figure 2- Annotated catchment map

Soil assessments were carried out in Field's 1,2 and 3. Field 4 was observed during a wet weather survey for overland runoff.
